**Geophysical Exploration Services
500 N. Plum Street
Lancaster, Pennsylvania
HCEA Job No. H19107**

September 12, 2019

Re: Geophysical Exploration
500 Block N. Plum Street
Lancaster, Pennsylvania
HCEA Project Number: H19107

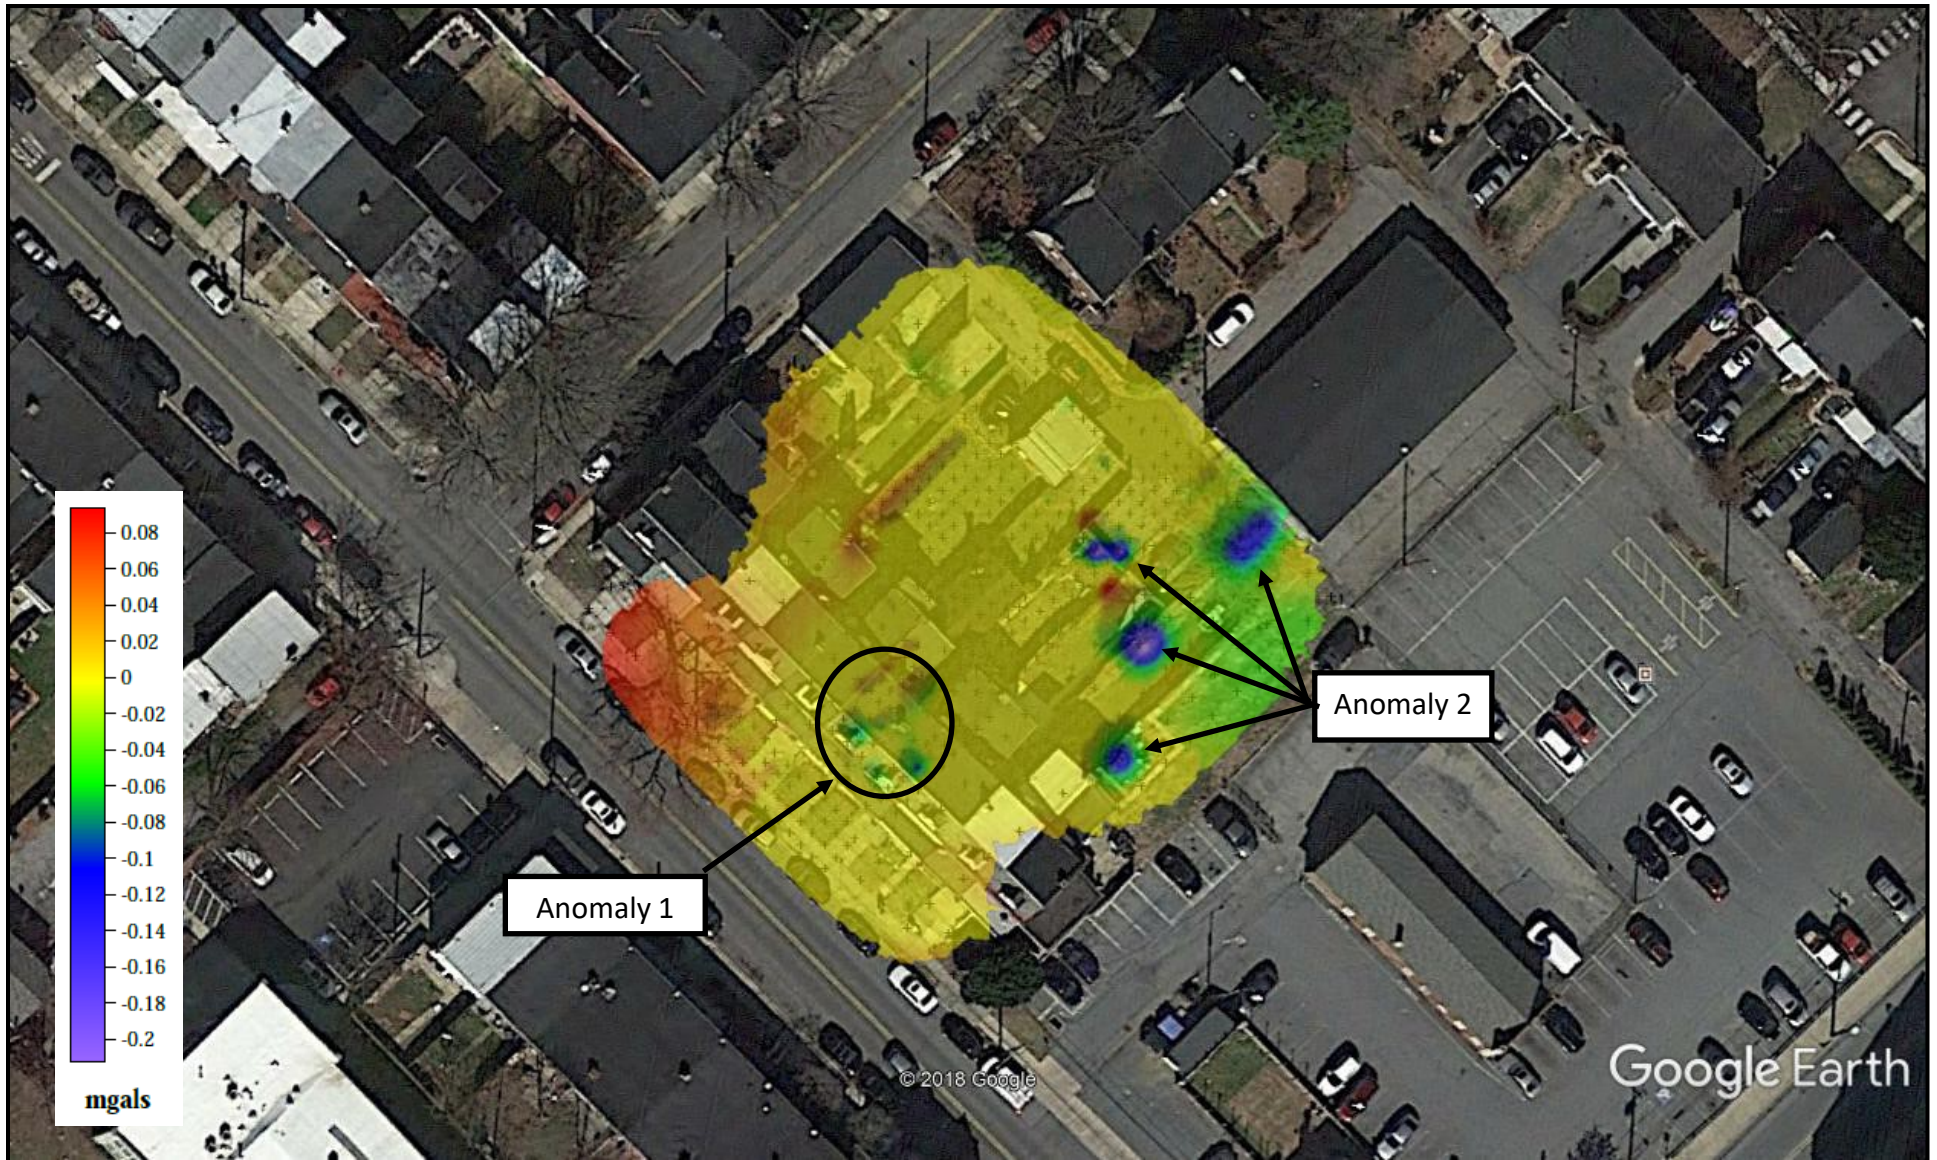
FIGURE - 2

Based on the microgravity image provided within the Appendix, the results indicated that two primary clustered areas of concern (anomalies) exist, as referenced as Anomaly 1 and Anomaly 2. Anomaly 1 area is located within the general area of the existing foundations of townhouse units 525, 527, and 529. Whereas, Anomaly 2 is located within the backyards of the townhouse units (#521, 523, 525, and 527) and extending into the rear alley behind the backyards of the referenced units. Please refer to Figure 2 in the Appendix for the location of these referenced anomalies.

While further investigation is needed to further clarify the structural constituents of the microgravitational anomalies, based on the survey and the structural conditions of the residences relative to Anomaly 1, the foundations may have been influenced by a bedrock fracture(s). As within Karst topography areas, fractures are known to facilitate soils migrating further into the subsurface thus producing relatively weaker soils underneath the foundations of the residences in that location. It should also be noted that, bedrock fracture(s) may be influencing the illustrated gravitational lows within Anomaly 2. The carbonate rocks that underly the Site have undergone several compressional tectonic events throughout their history, each likely producing fractures

When comparing the geophysical surveys relative to the existing structural distress present with the structures (units #525, 527, and 529), it is our opinion, that a subsurface geologic condition exists which appears to be facilitating structural disturbances to the aforementioned addresses as well as the surrounding areas. Consequently, these subsurface issues will need to be evaluated and remediated in order to mitigate the likelihood of further structural disturbances to those residences. Therefore, HCEA recommends that Anomalies 1 and 2, where accessible, be further evaluated by performing Standard Penetration testing at locations designated by our office.

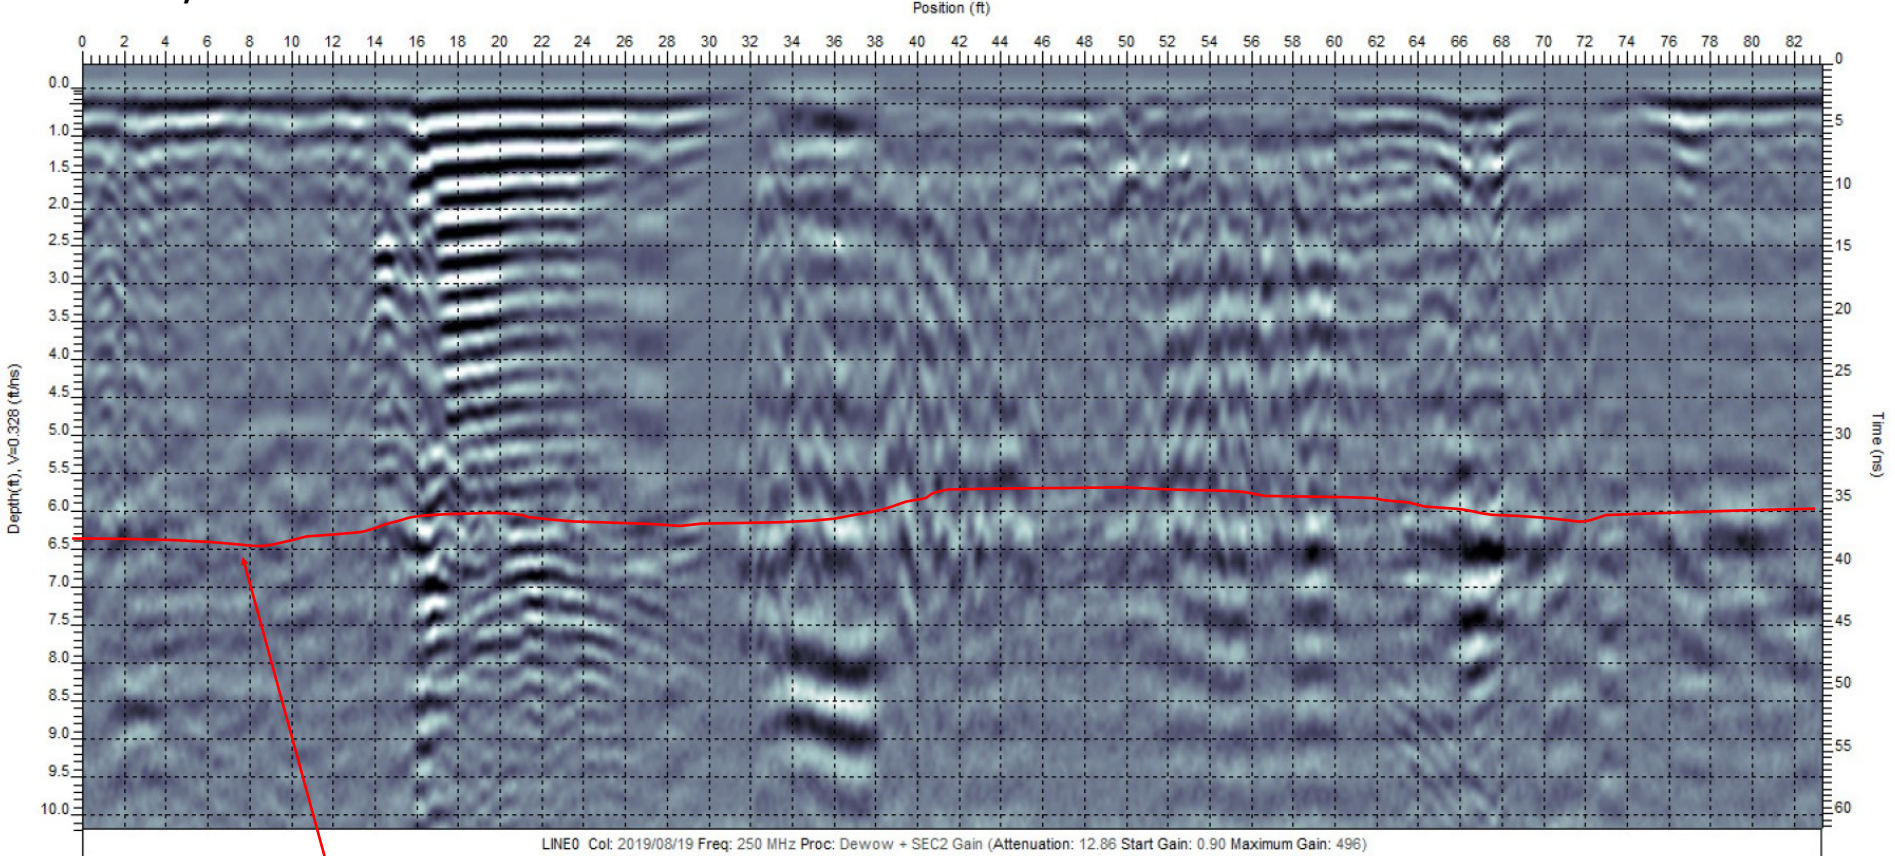
FIGURE - 4

Appears to be natural soils

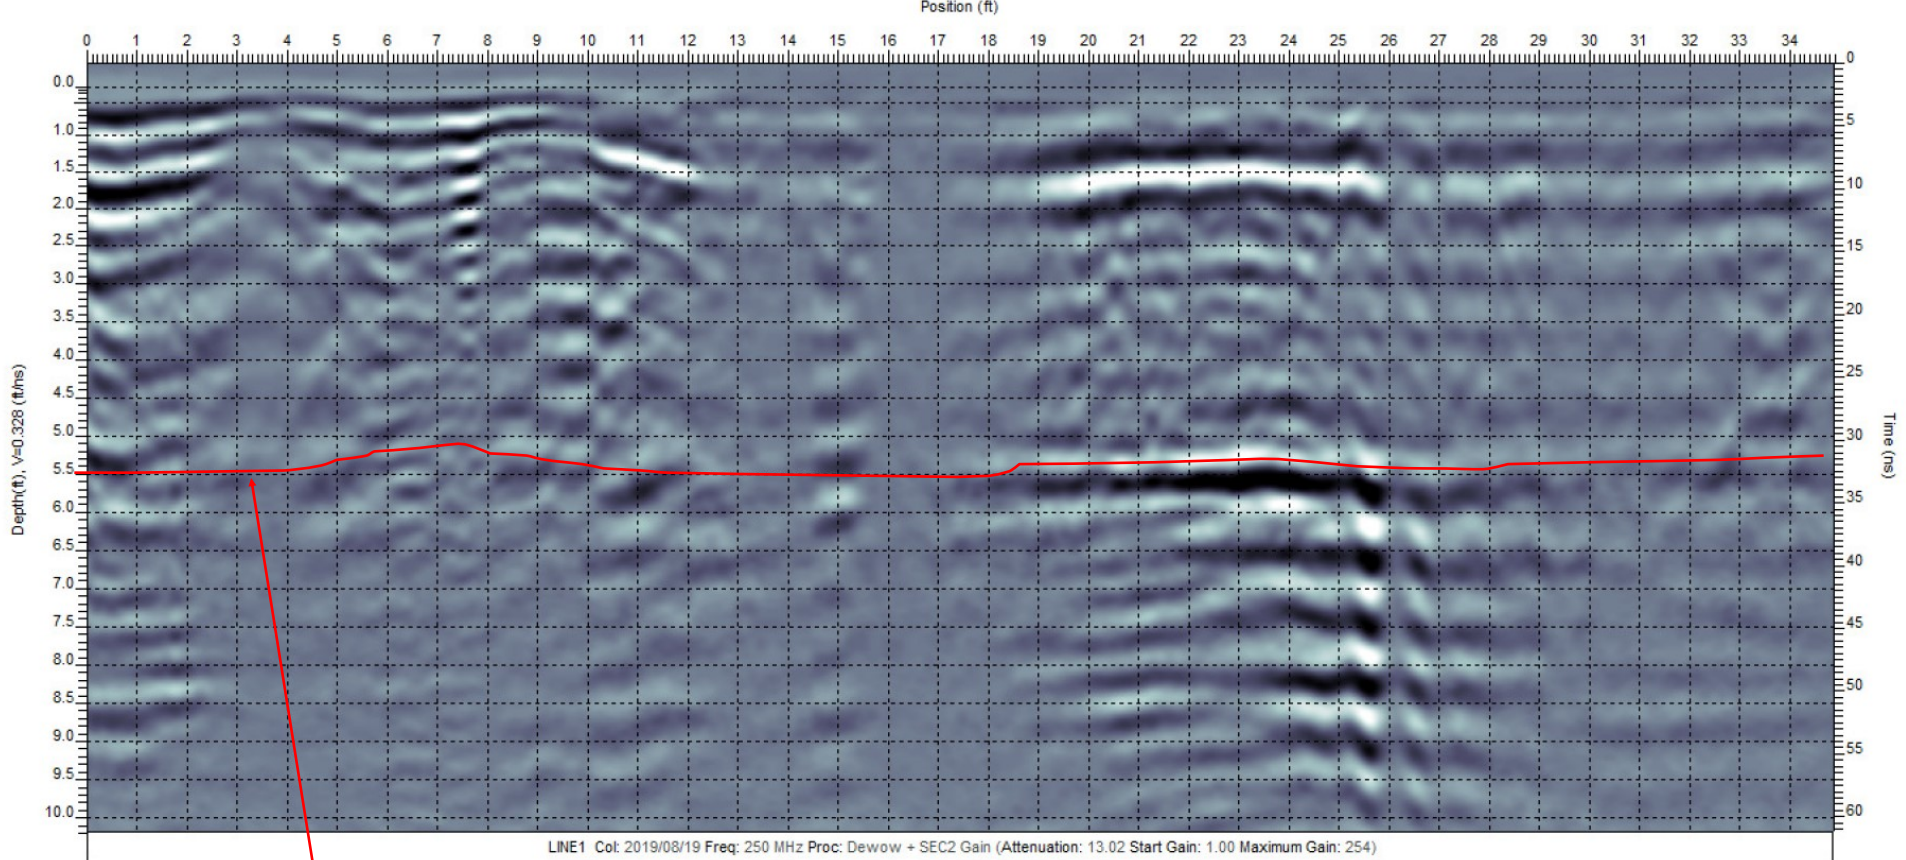
FIGURE - 5

Appears to be natural soils

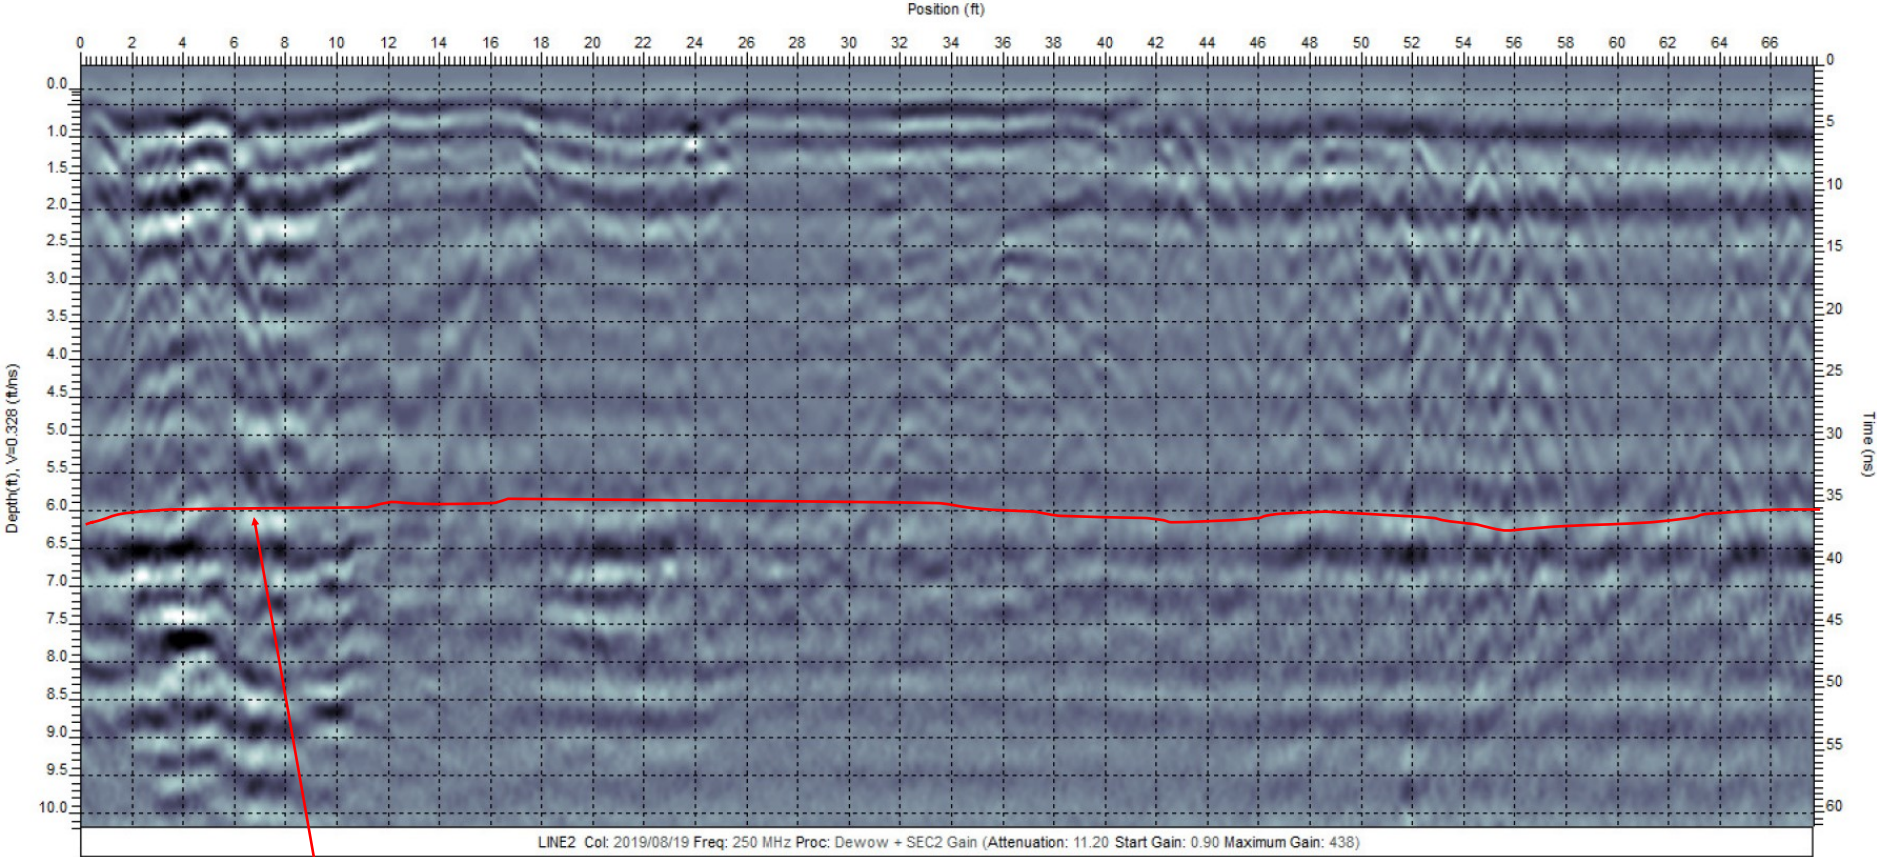
FIGURE - 6

Appears to be natural soils

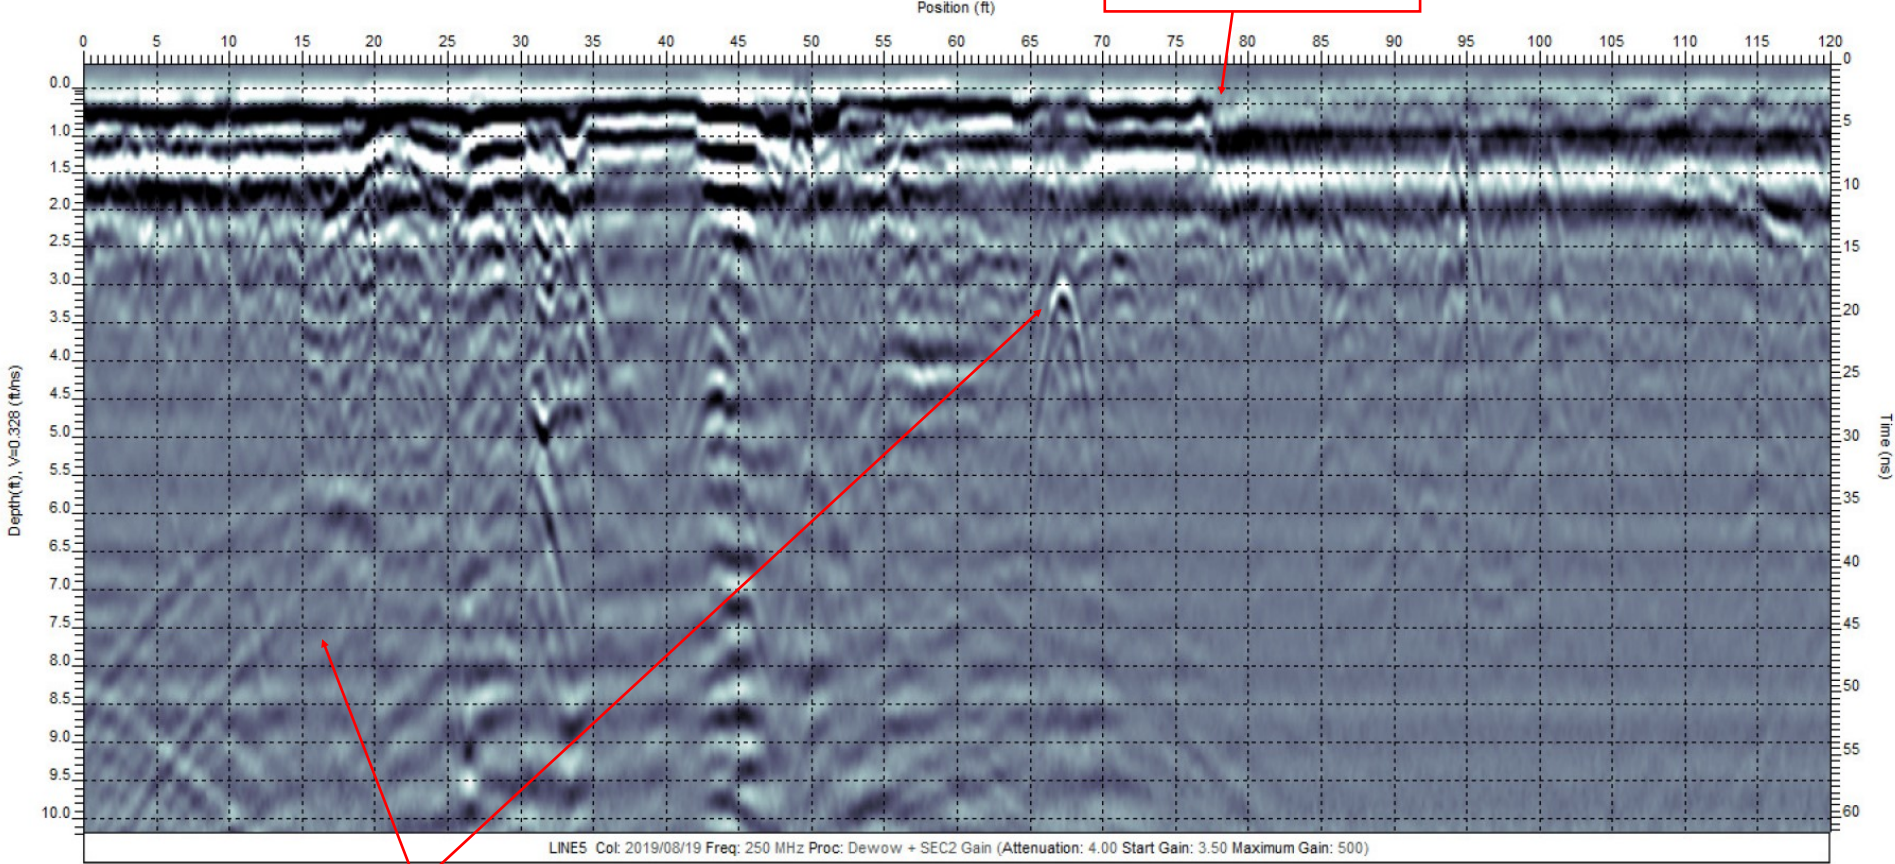
FIGURE - 9

Concrete - Grass Contact

Possible Utility

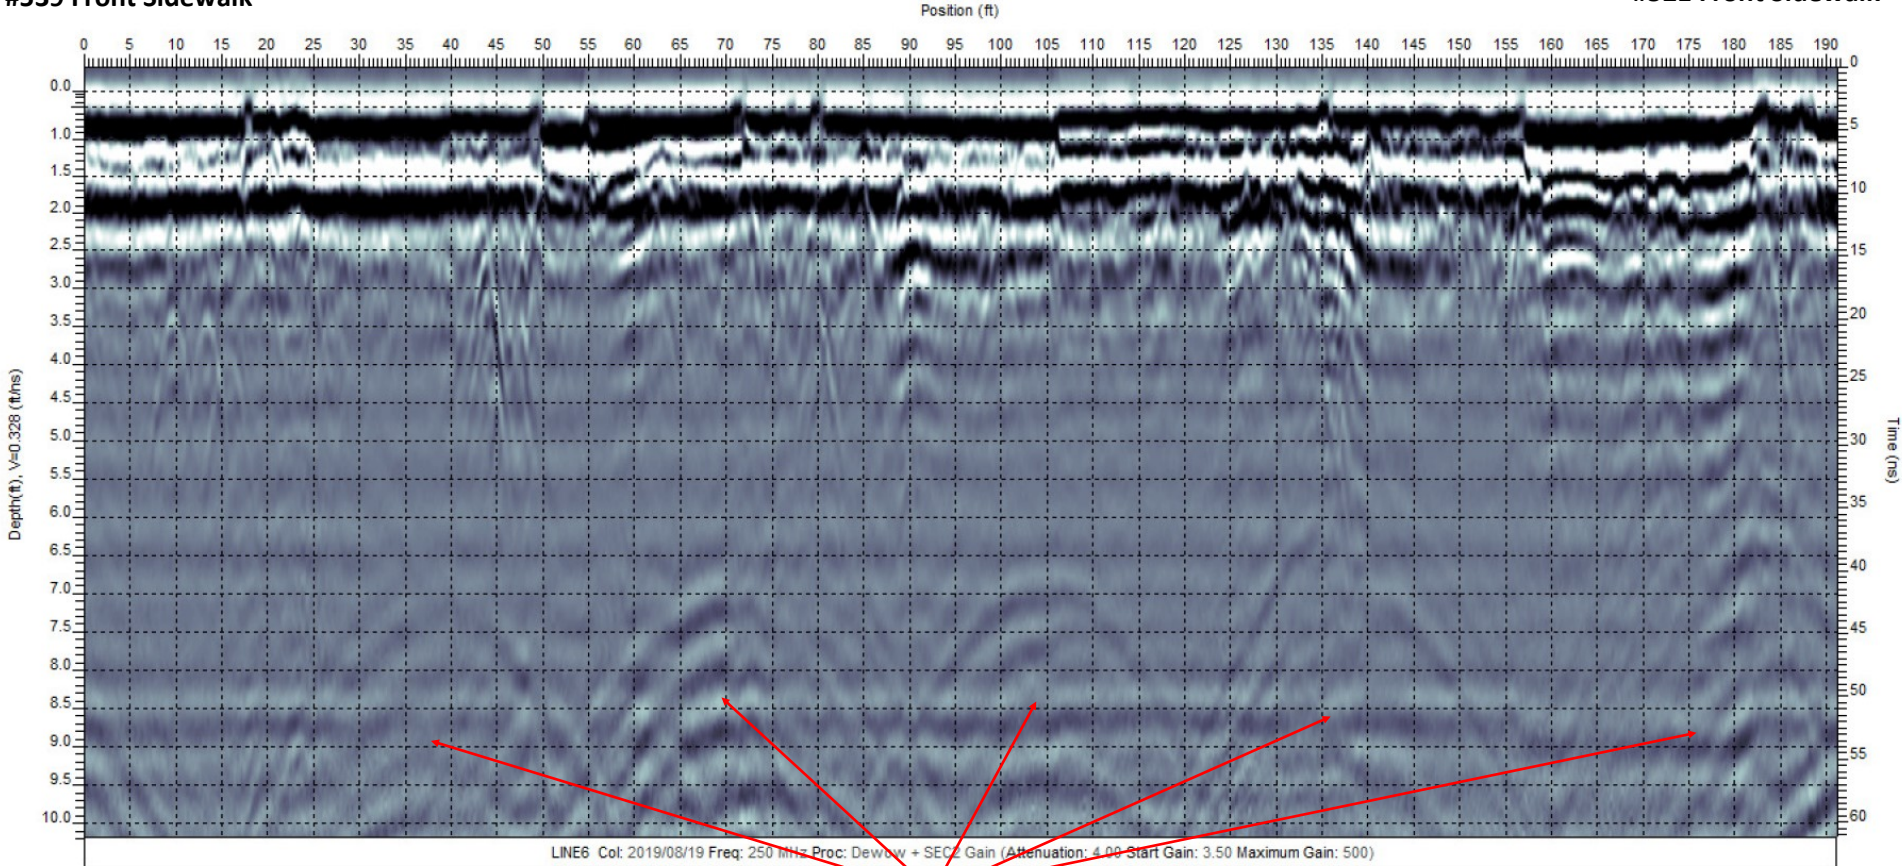
FIGURE - 10

Possible Utilities

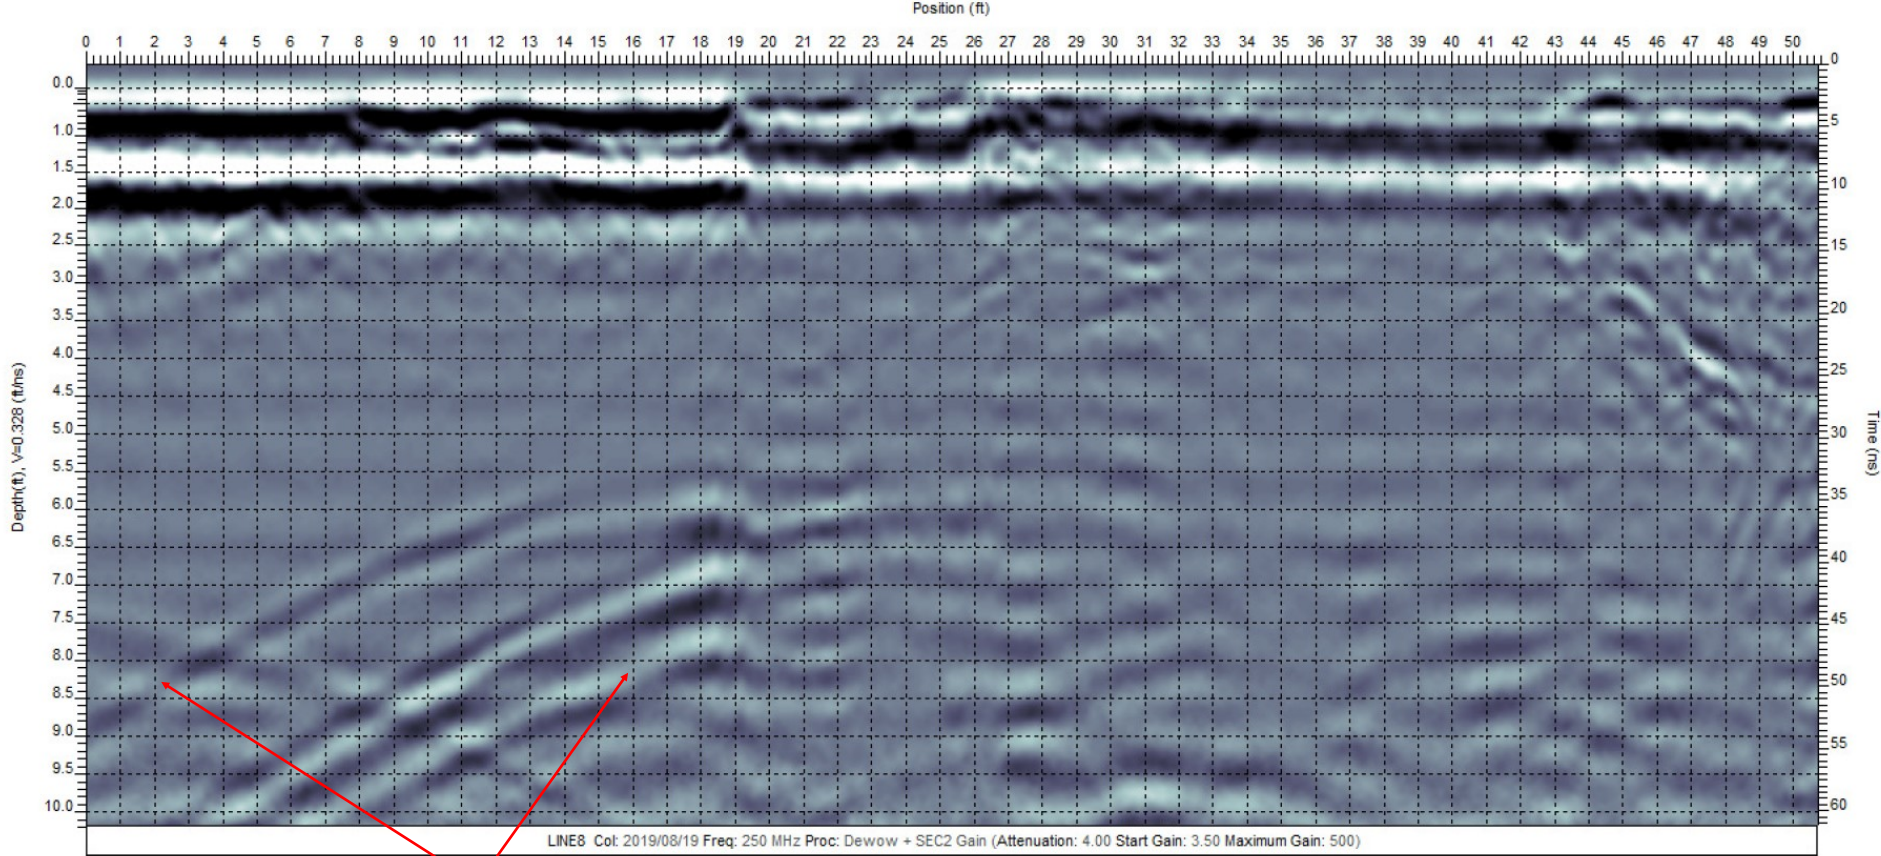
FIGURE - 12

Possible Utilities

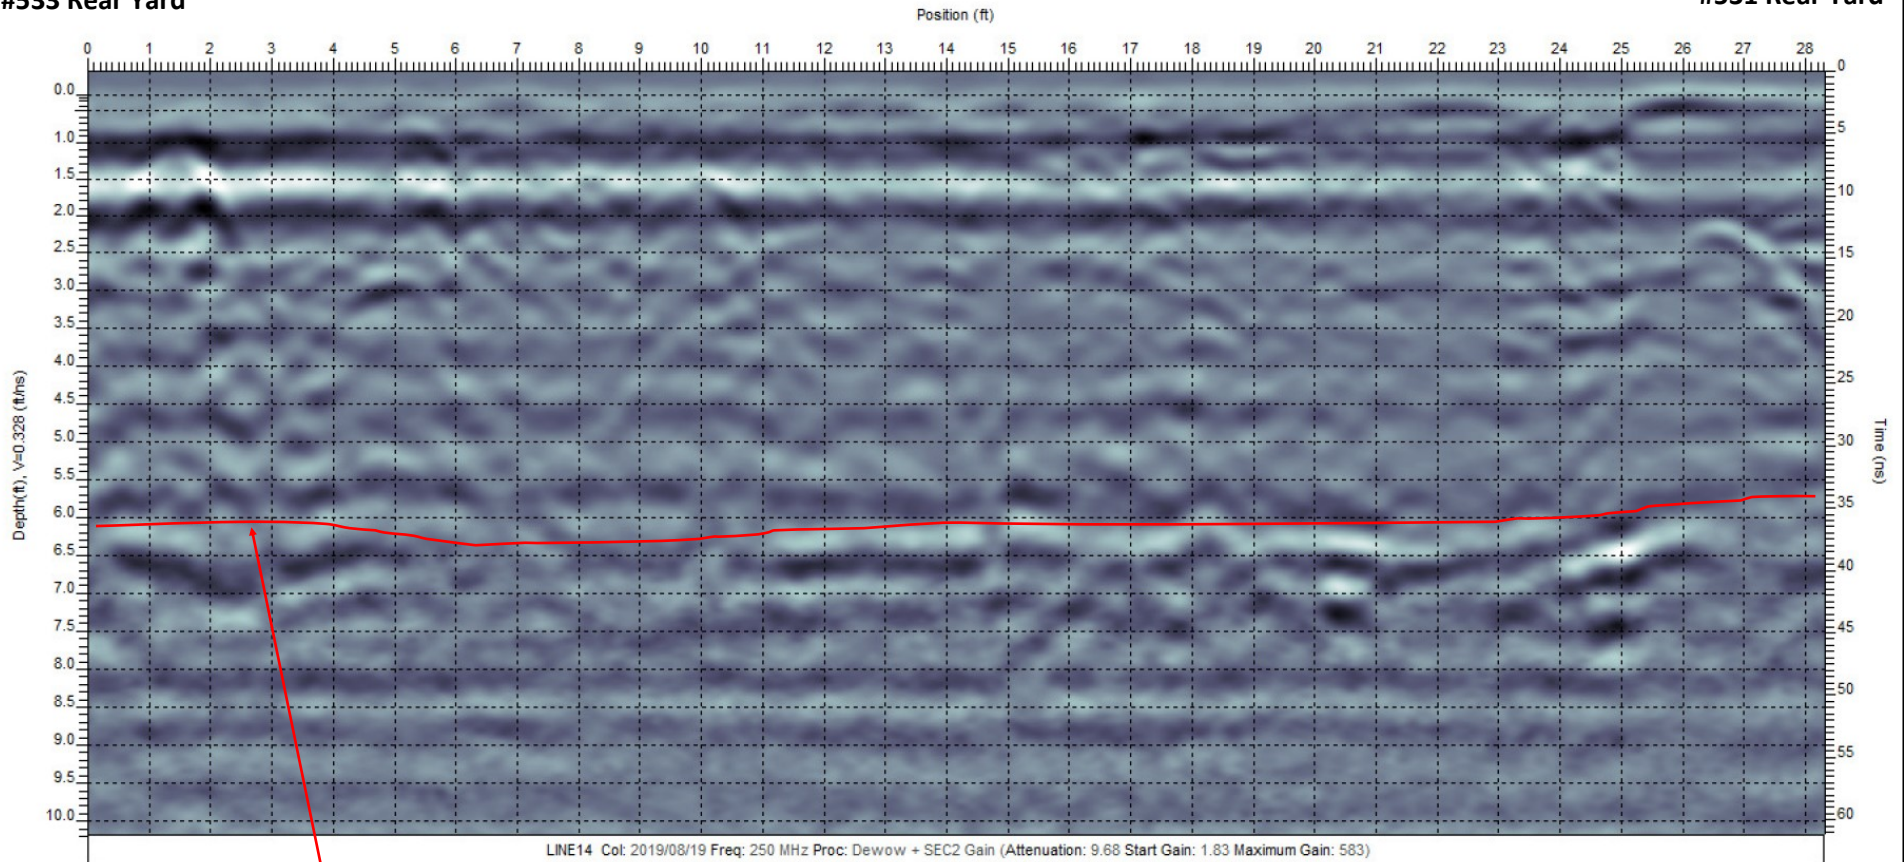
FIGURE - 15

Appears to be natural soils
