**Geophysical Exploration Services
500 N. Plum Street
Lancaster, Pennsylvania
HCEA Job No. H19107**

September 12, 2019

Re: Geophysical Exploration
500 Block N. Plum Street
Lancaster, Pennsylvania
HCEA Project Number: H19107

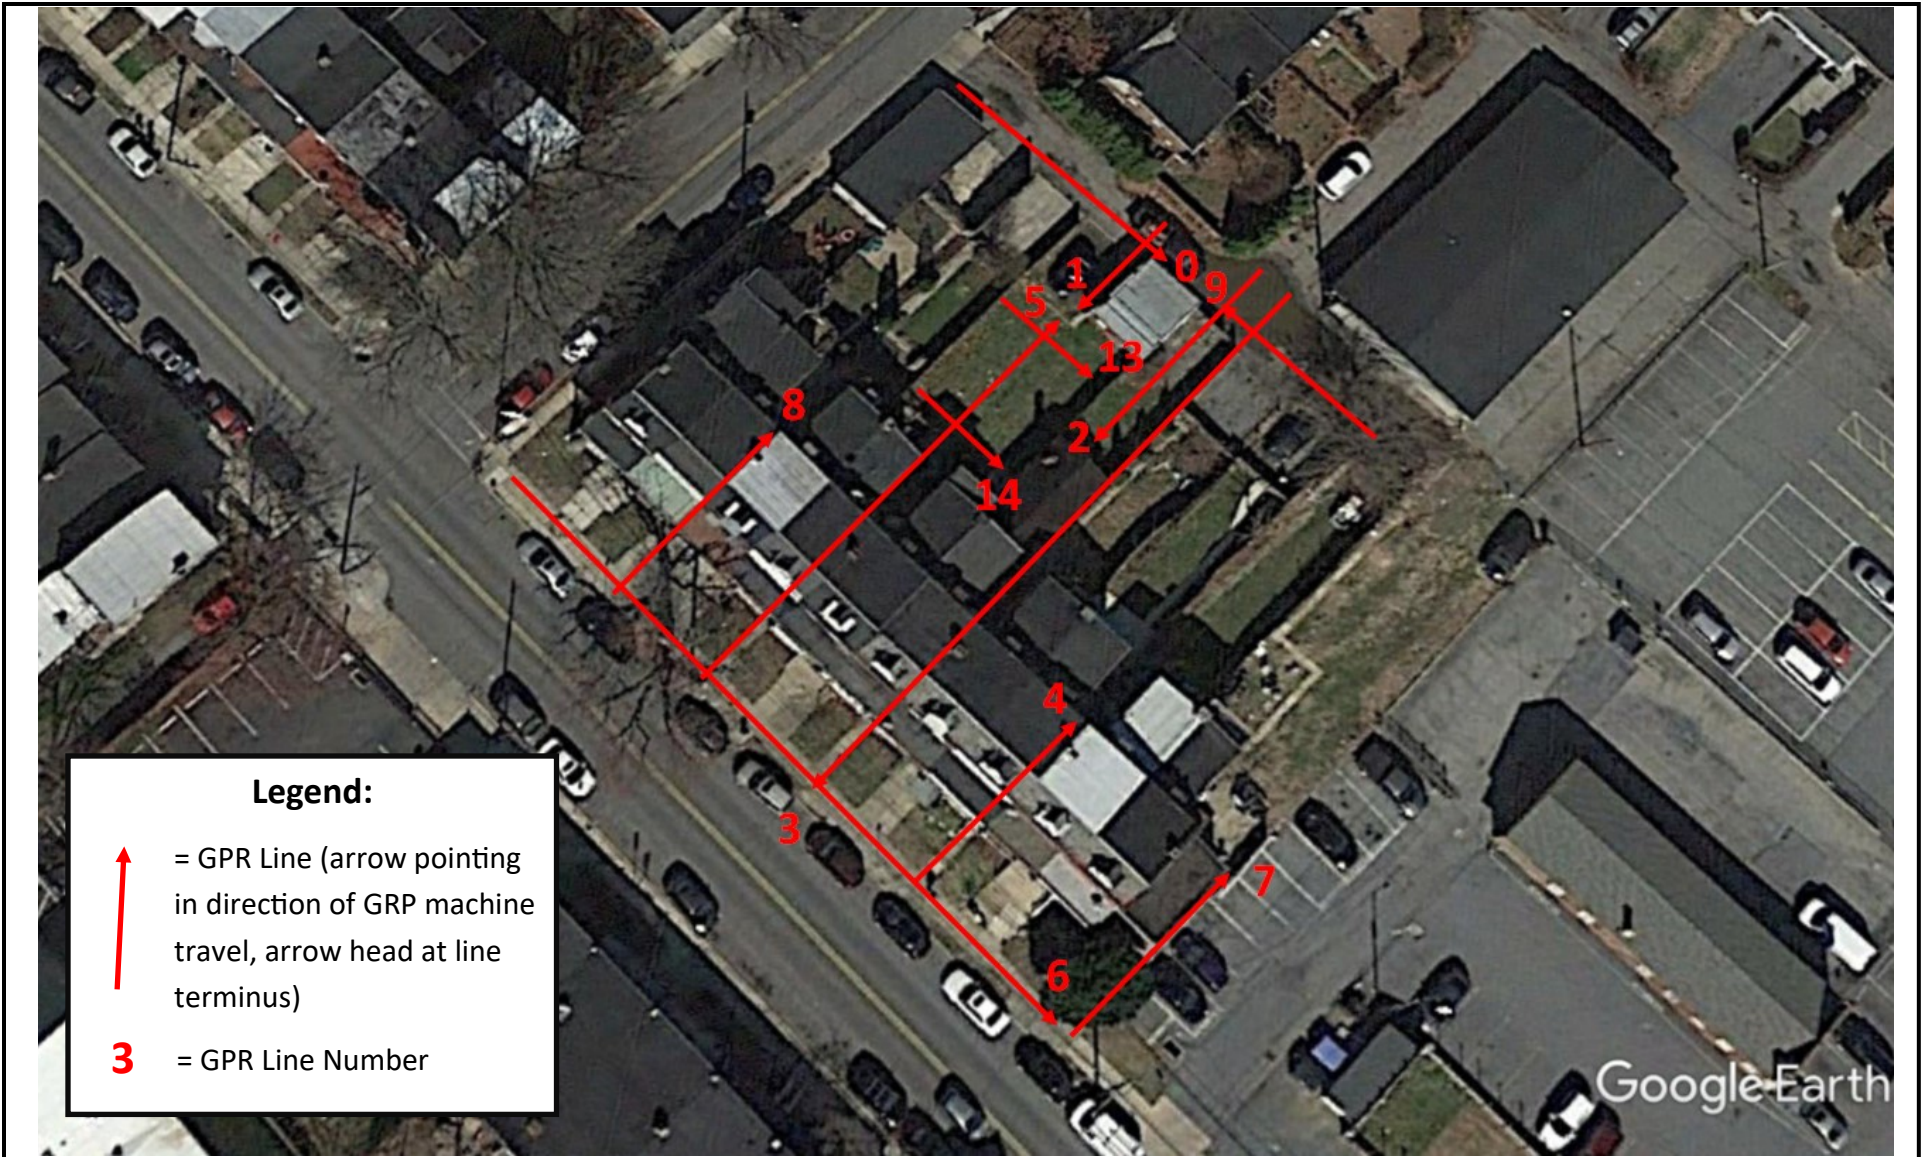
FIGURE - 3

GPR scanning of the Site was performed with singular survey lines numbered 0 through 14. Line locations were chosen to gain a representative understanding of the subsurface conditions within the alleyway and yards of the N. 500 block. At some locations, saturated subsurface conditions resulted in increased signal attenuation, thus limiting the GPR resolution and effective depth of investigation. These scans provided 2-Dimensional graphs of the GPR echoes within the surveyed areas. Please refer to the attached GPR Line Survey Location in the Appendix (Figures 3-14) for the survey locations and resulting images.

Based upon the GPR data, at locations not covered by bituminous asphalt and/or concrete, approximately, the top two feet of the surface appears to consist of a “topsoil” horizon. Beneath this layer, a strong reflector is not generally observed until 5.5 to 6.5 feet below the existing site grades. This reflector may represent a change in subsurface materials. The materials represented between 2 and 5.5 to 6.5 feet produce a generally non-reflective GPR signature, suggesting a relatively homogenous composition of the materials. A possible interpretation is that the reflector at 5.5 to 6.5 feet represents the contact between fill material (above) placed at the time of primary construction of the residences and undisturbed/natural soil contact zone. Where the scans were performed in areas where concrete and bituminous asphalt were present, the scans indicated that these layers were approximately up to one foot in thickness. Multiple possible utility lines at varying depths are observed, particularly in the front of the residences.

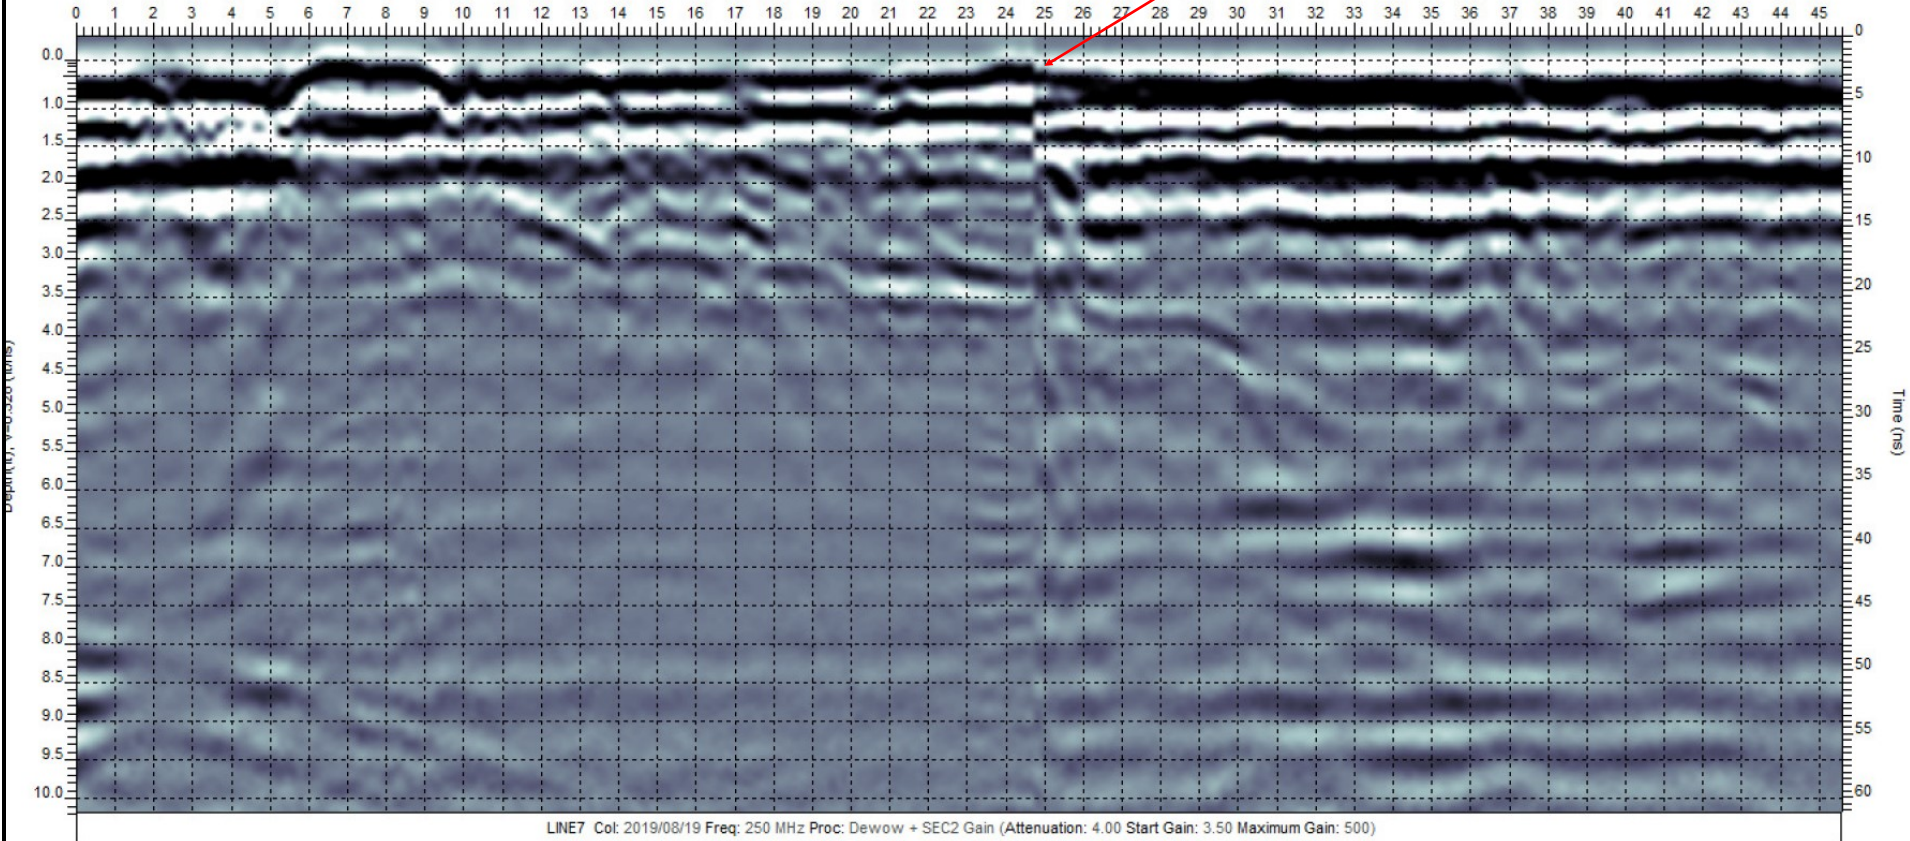
Step in Sidewalk
